Report No. FAA-RD-80-78 FAA-CT-80-35

THE BRAKING PERFORMANCE OF AN AIRCRAFT TIRE ON GROOVED PORTLAND CEMENT CONCRETE SURFACES

Satish K. Agrawal Hector Daiutolo

INTERIM REPORT

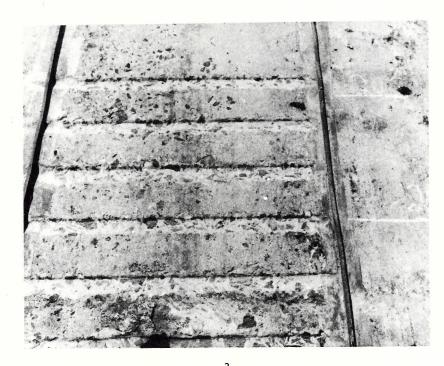
GROOVES PRODUCED
BY SAW—CUTTING

GROOVES PRODUCED
BY WATER-JET CUTTING

GROOVES PRODUCED BY REFLEX-PERCUSSIVE PROCESS

FIGURE 3. COMPARISON OF GROOVES PRODUCED BY HIGH-SPEED WATER JET TECHNIQUE, BY SAW-CUTTING TECHNIQUE, AND BY REFLEX-PERCUSSIVE PROCESS
